TA PROJECT REPORT

Proposal reference number¹	JS3_CALL_1_REF_4036b_EuroFluoro
Project Acronym (ID)²	EuroFluoro II
Title of the project³	Field testing and validation of a new multiparameter sensor in European Coastal waters 2
Host Research Infrastructure⁴	Marine Institute
Starting date - End date⁵	26-08-2021 - 20-12-2021
Name of Principal Investigator⁶ Home Laboratory Address E-mail address Telephone	Dr James Kirkbride Chelsea Technologies 55 Central Avenue West Molesey Surrey KT8 2QZ UK jkirkbride@chelsea.co.uk +44 (0)20 8481 9000

several monitoring applications. EuroFluoro will test the usability of the VLux AlgaePro fluorometer, having 4 excitation bands and one emission band, in optically complex coastal waters.

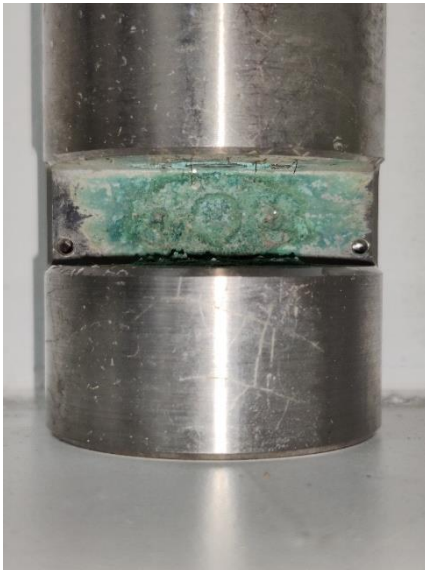
Upon raising the sensor, severe corrosion of the copper bezels surrounding the windows was observed. The sensor housing is made of titanium and the copper bezels surrounding the windows are incorporated for the anti-biofouling properties of copper. The experiment was intended to look at the effectiveness of the inclusion of a UV light source for anti-biofouling above that of the copper bezels alone. In actuality, the corrosion of the copper has resulted in the deposition of chemical contaminants on the windows. This occurred on both the complete sensor and on the control housing which contained no electronics.

Galvanic corrosion of dissimilar metals is of course a common problem. Nevertheless, the scale of the corrosion seen here in just four months was a surprise. VLuxs have been deployed in freshwater with no sign of any corrosion and while saltwater is obviously a much more corrosive environment than fresh, this was not expected to be an issue over the length of the deployment. A VLux has previously been deployed on a FerryBox system in the Baltic sea without showing this type of corrosion, although that system was not fully submerged and was subject to regular cleaning.

The anodic indices of titanium and copper differ by just 0.05 V, a value generally considered suitable even for harsh environments. Moreover, copper generally corrodes to form basic copper carbonate which forms a layer that protects the remaining copper underneath (as on copper roofs or the Statue of Liberty). The exact chemical makeup of this copper patina depends on the environment. In this instance the corrosion has not simply formed a protecting layer but spread to cover the sapphire windows and some of the titanium housing adjacent. This coating raises significant doubts over the validity of the acquired data.

Due to the problems of corrosion and leaking, we do not have confidence in the validity of the acquired data. For this reason, we are not able to comment on the efficacy of the UV illumination for biofouling prevention. We will further investigate the corrosion issue to try to better understand the problem and see whether there is a way the copper bezels can be used in marine environments.

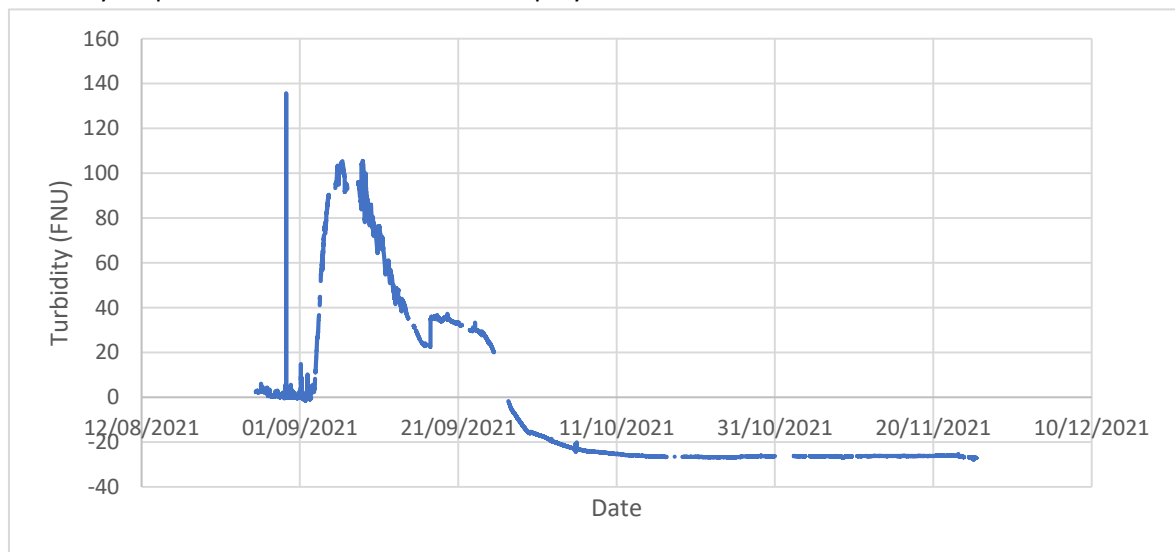
As an example of the effect the chemical fouling has had on the data, below is shown the VLux turbidity response over the course of the deployment:

The turbidity rises sharply shortly after deployment then begins to fall. It eventually plateaus at a negative reading. This is because there is normally a small amount of scatter that is measured in zero turbidity water which produces an offset in the readings. With the windows clouded over, both the IR light emitted and the scattering is blocked and the offset applied to the calibration causes a negative value to be output. We cannot assume that the data preceding the negative values is valid since build-up of fouling must have occurred during this period and affected the data. It is possible that initial build-up may have caused an increase in scatter, but this is conjecture and would require specific investigation to understand.
